Report on the investigation of
the grounding at high speed of the RIB

Sooty

Calve Island, Isle of Mull

Report No 22/2009
October 2009

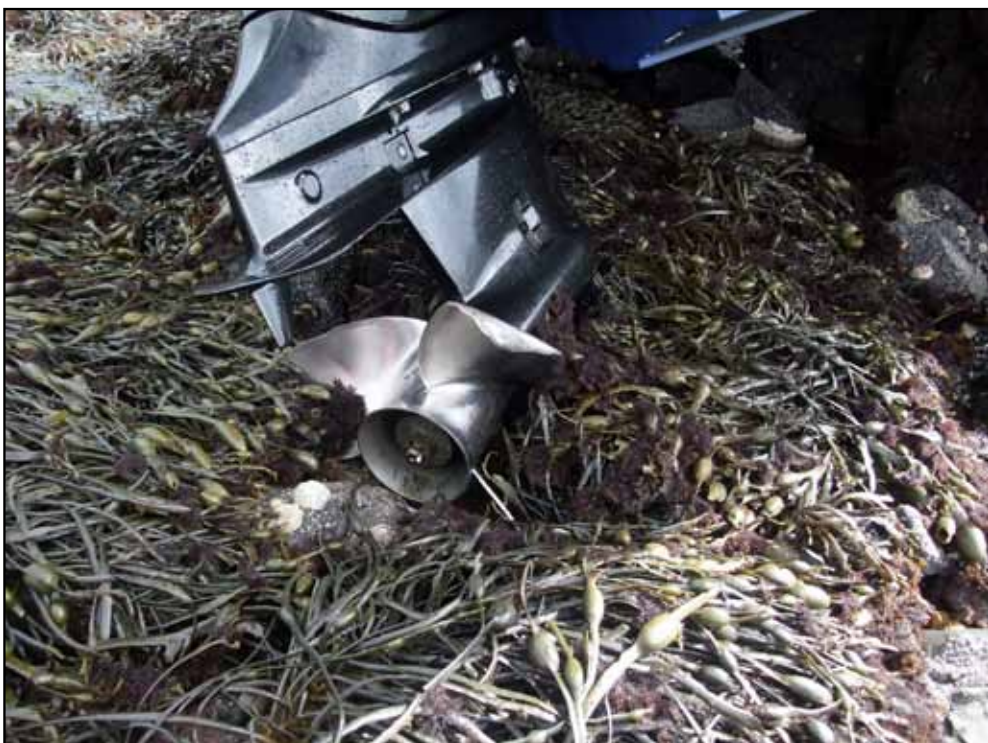
Figure 10

- The port and starboard bow section showed signs of impact damage. Sections of gel coating had been removed, and loose strands of grp matting were visible (**Figure 9**). Superficial damage to the gel coating was observed along the lines of the hull from forward to aft.
- The forward buoyancy tube, incorporating port and starboard bow sections, was deflated.
- All three propeller blades had been damaged (**Figure 10**).

Damage to propeller blades

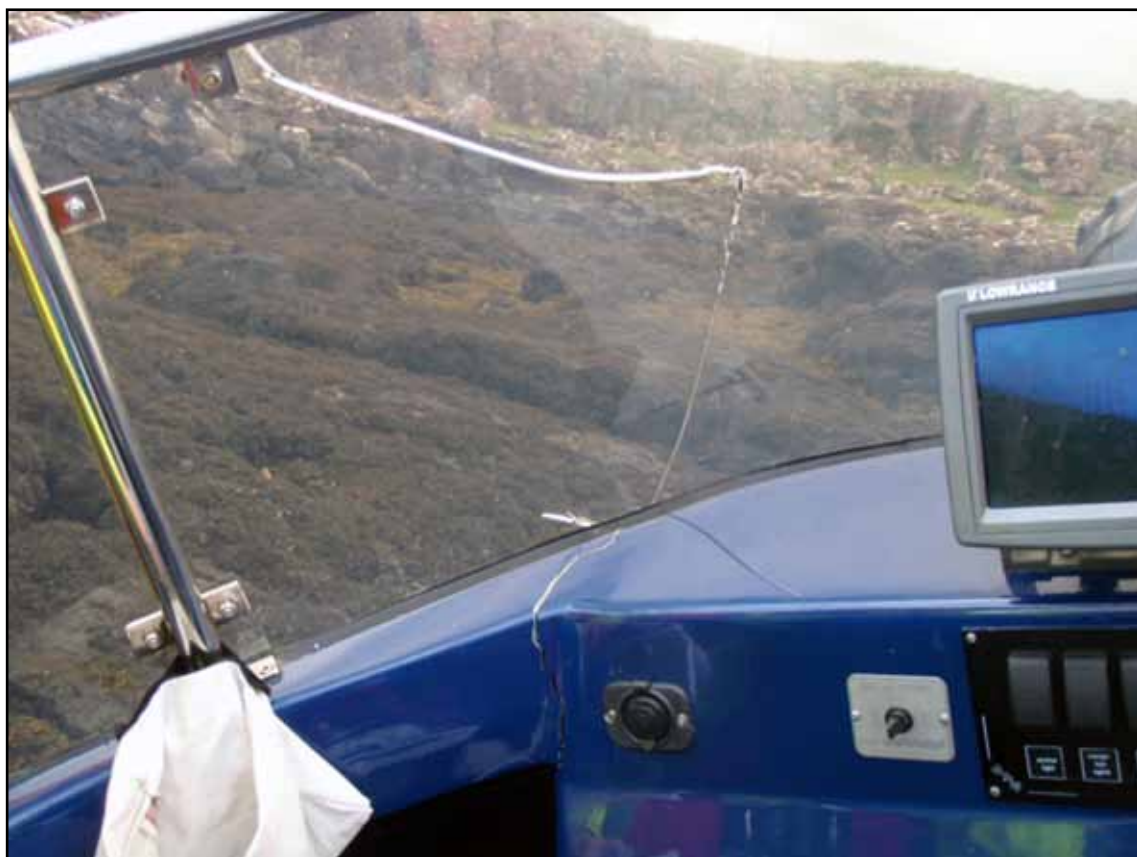
Figure 11

- A 20cm crack was identified inside the anchor chain locker.
- The tinted visor was cracked, the line of the crack continued into the main grp console (**Figure 11**).
- The magnetic compass on the top right hand side of the instrument panel had been dislodged.

Damage to tinted visor and the console

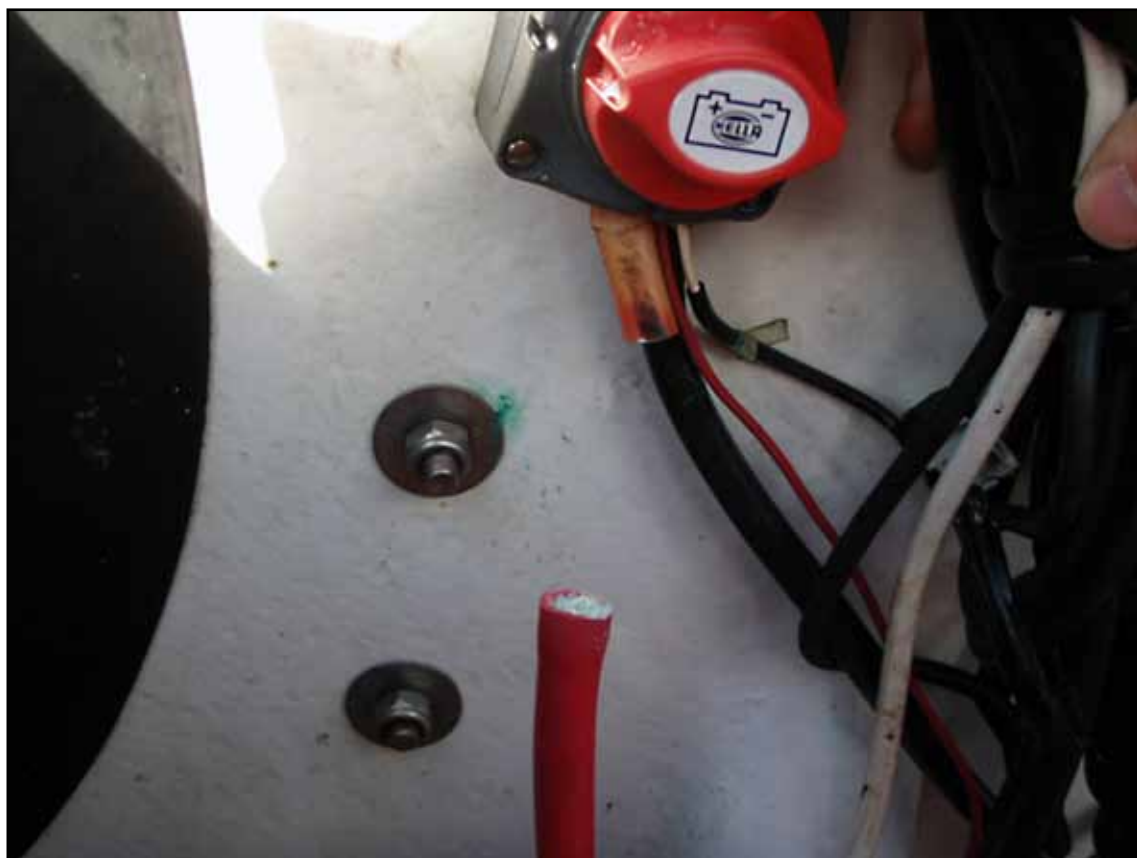
Figure 12

- The battery, housed in an unsecured plastic container, had both positive and negative leads attached. The positive lead had been pulled from the battery isolation switch which was secured to the transom. The crimped connection was corroded (**Figure 12**).

Positive battery lead pulled from the isolation switch

The total loss of electrical power, which resulted in the crew being unable to use the VHF radio after the grounding, was attributable to the battery not being properly secured. This allowed it to be thrown forward on impact, causing the corroded positive terminal to be ripped from the main power supply switch. The position in which the rocker switches were later found must be treated with caution, given that three of the crew were thrown into the instrument panel, and that the coxswain might have disturbed the rocker switches when attempting to use the VHF radio to alert the coastguard.

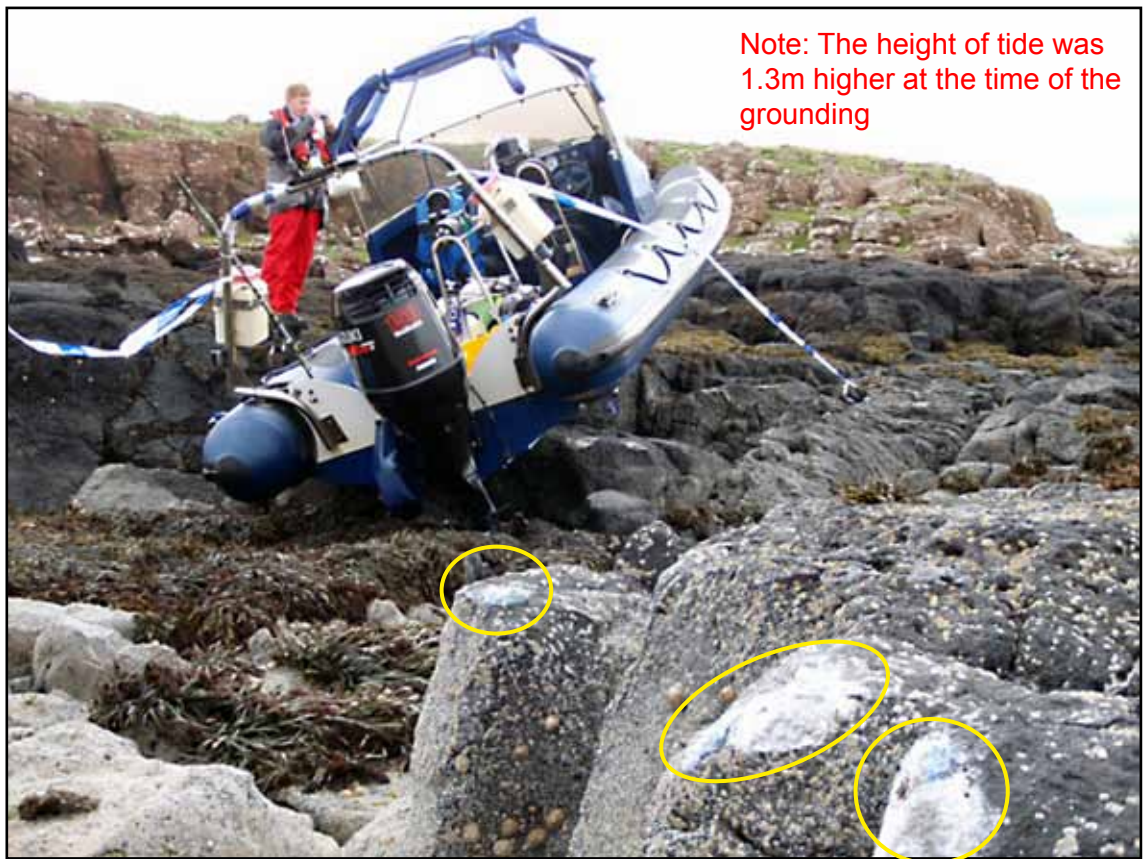
Figure 13

- White gel coat was observed on a rock face to starboard (**Figure 13**).
- Blue anti-foul paint from the underwater section of the hull was observed on several rock faces; directly on the line of approach.
- An underwater scar on a flat rock face, directly on the line of approach (**Figure 14**).

Evidence of gel coat to starboard

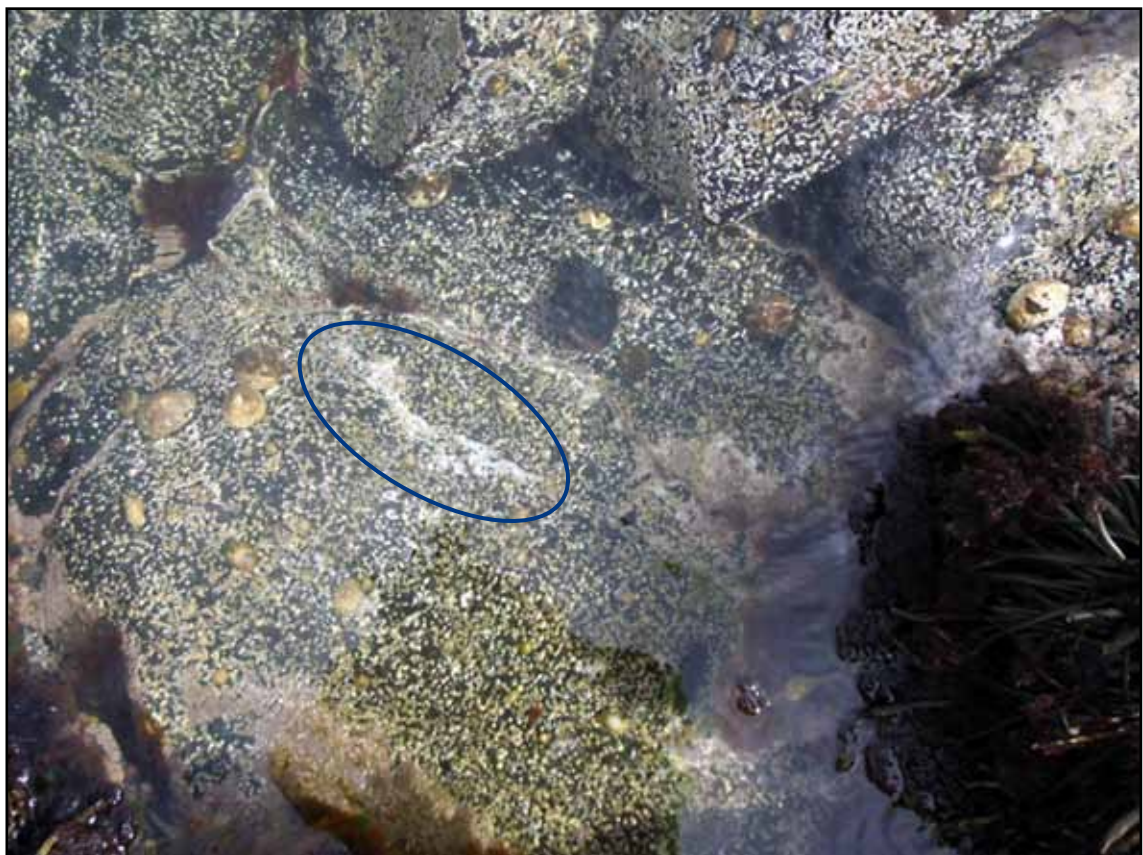
Figure 14

Impact point of outboard motor leg

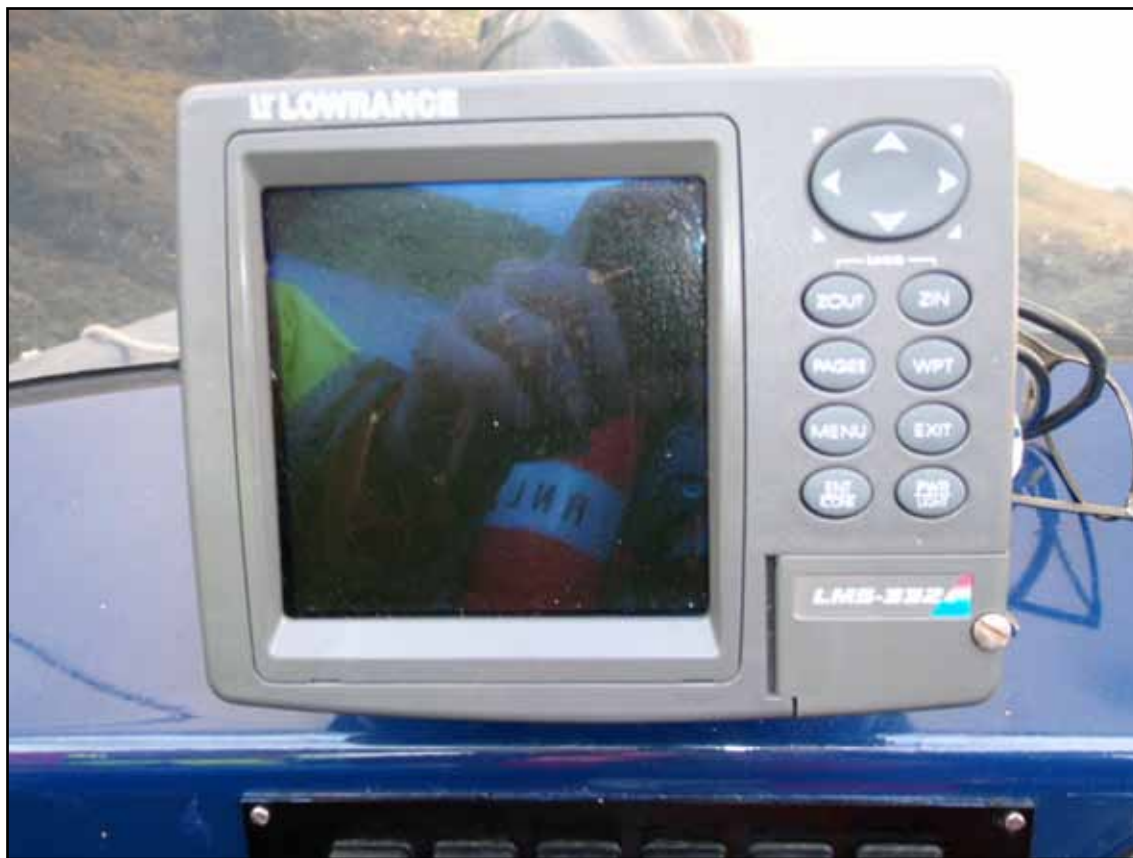
Lowrance GPS unit removed from Sooty

over the first trail point. The default automatic setting creates a trail by placing a trail point every time the unit changes direction. It was not possible to recover speed, course and time data from individual track points.
