# Part 3 – Small Craft

## Teenage Tragedy

## Waves Aren't Always Fun

# Injured, But Lucky to be Alive

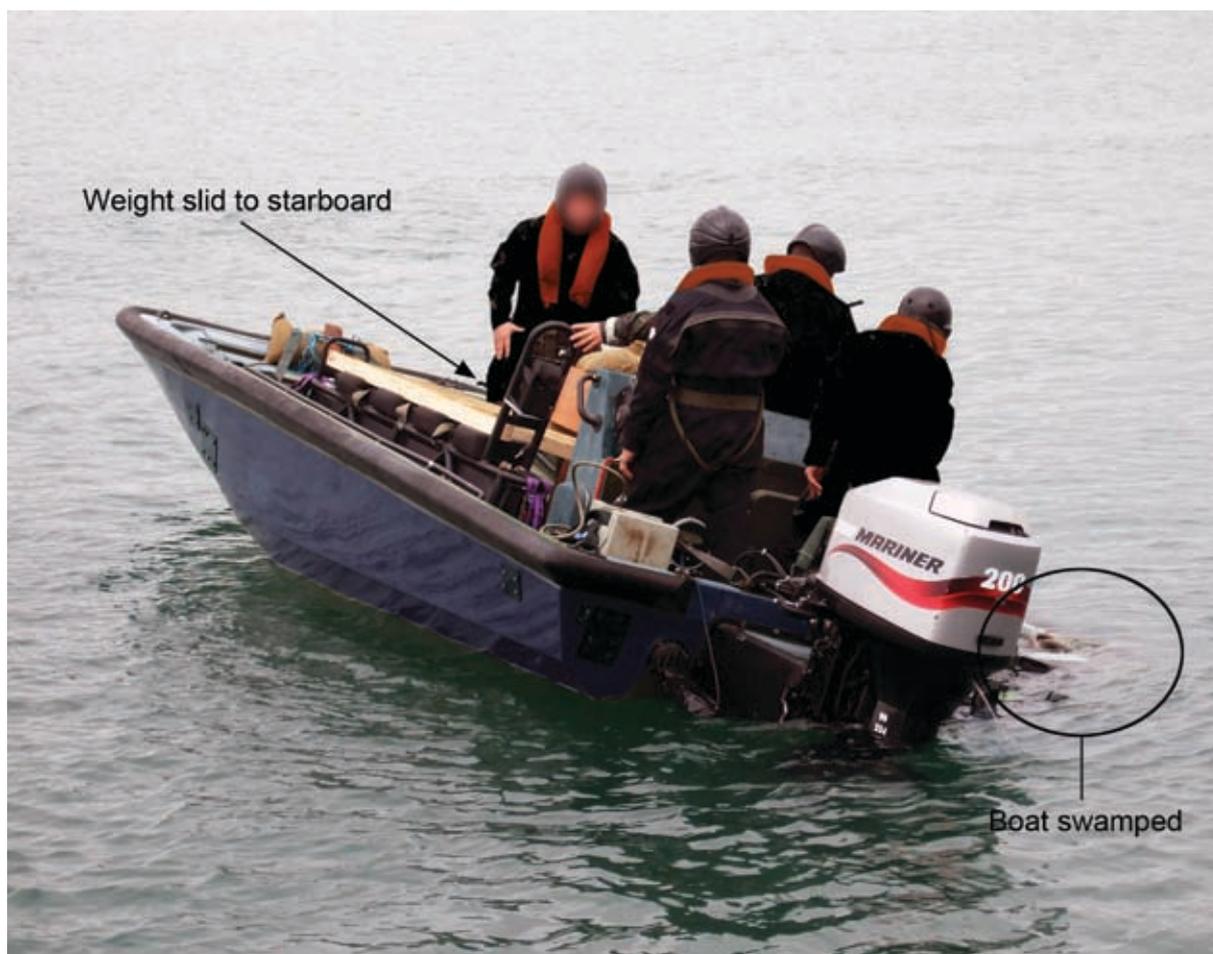
The boat started taking on water over its bow and sides, which then accumulated on the deck and caused the boat to loll to port. To address the problem, the instructor in charge turned his boat into the sea and stopped. The 'elephant's trunk'<sup>1</sup> on the port side of the aft transom was lowered. Speed was then increased and a turn to starboard was commenced. As the boat started to turn, the teenagers seated on the port side of the boat were instructed to transfer to the starboard side. As they moved, the boat heeled to starboard and capsized.

Capsizing trial illustrating weight shift and boat swamping

2. The accumulation of water on the decks of any boat is dangerous, and can quickly lead to the loss of stability where it is able to move freely from one side of a vessel to the other. Prevention is easier than cure, and the use of 'elephant's trunks', self-bailers, freeing ports and bilge pumps is usually very effective, even in rough conditions. However, once water has accumulated and can move unchecked, great care must be taken not to counter any apparent list with the movement of people or weights. This is unlikely to have the desired effect and can result in capsizing. Limiting the movement of people on the boat and getting rid of the water by all means available is the safest and simplest solution.

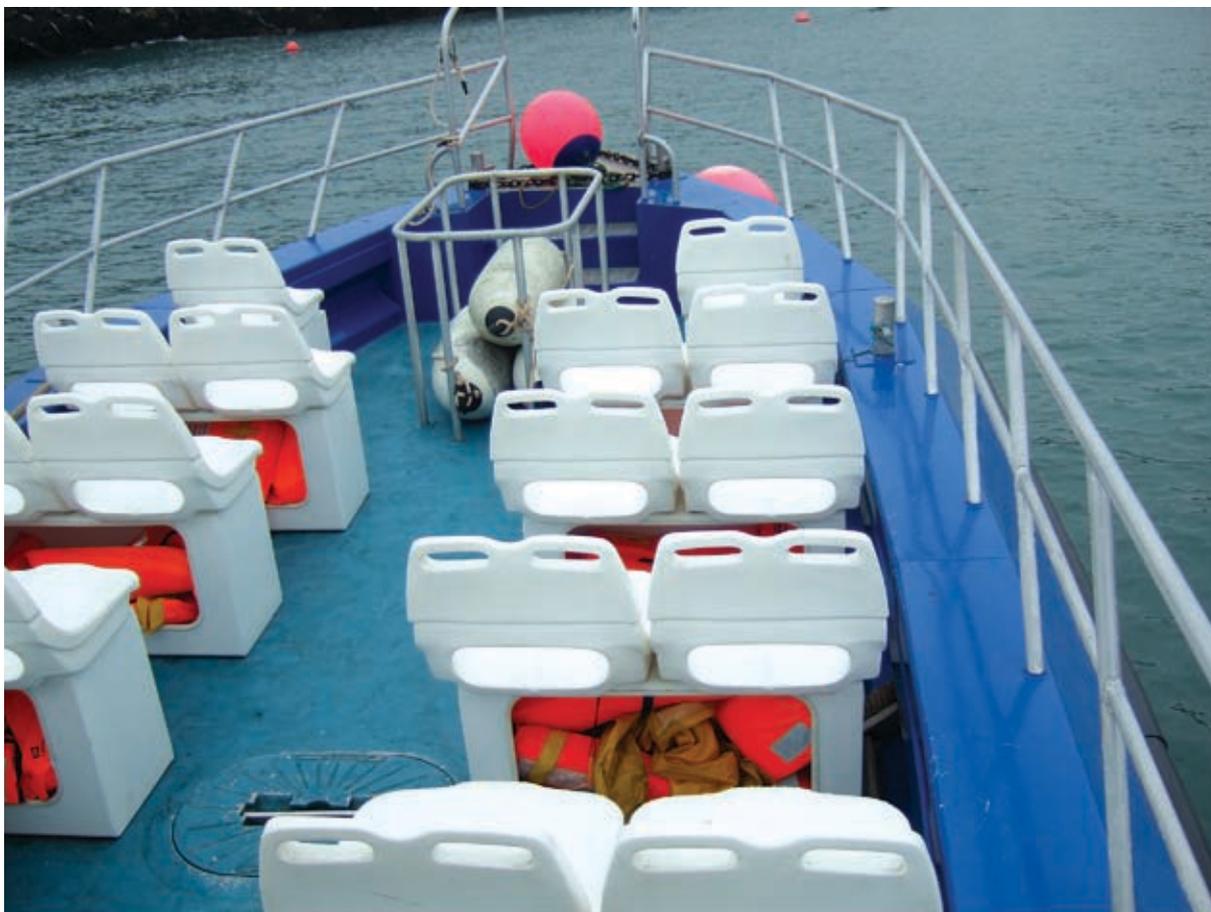
Figure 1: Rear view of the high speed vessel

A small high speed vessel was employed to conduct pleasure trips for tourists. The vessel was skippered by an experienced helmsman and there was one crewman on board, who also acted as the tour guide for the passengers.

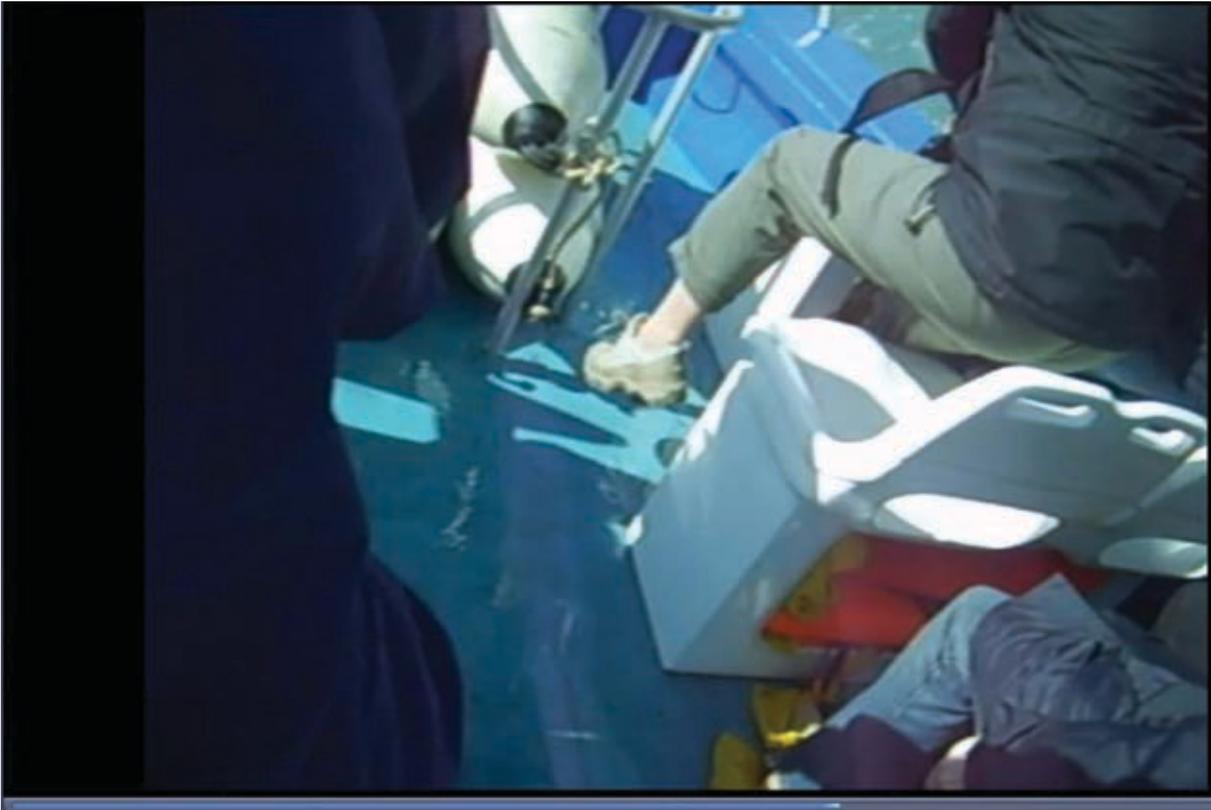
Figure 2: Photograph of a passenger being lifted from her seat by a wave

While the boat was in the channel, a single steep wave, roughly 2m in height, rose up immediately ahead of it. Despite the skipper's best efforts, he was unable to stop the vessel slamming heavily as it dropped off the back of the wave. The passengers landed heavily on

their seats as the vessel slammed down. A man seated at the front of the vessel collapsed to the deck in great pain, and many of the other passengers reported they were injured.

Travelling at speed on rough water, or even just encountering a single large wave, such as experienced here, can expose occupants of RIBs or similar vessels to high acceleration forces and shock loads as the vessels they are in slam into the water. These forces can result in serious injuries, especially back injuries, being sustained. A number of actions can be taken to reduce this risk, including:

1. Providing proper seating, handholds and, if appropriate, restraints for all passengers and crew.
2. Briefing passengers to adopt the correct posture to minimise the risk of injury by maintaining a straight spine, using handholds, and absorbing some of the shock through slightly bent legs. The safety brief should also emphasise that an inappropriate posture could increase the risk of injury.
