Report on the investigation of
the grounding at high speed of the RIB

Sooty

Calve Island, Isle of Mull

Report No 22/2009
October 2009

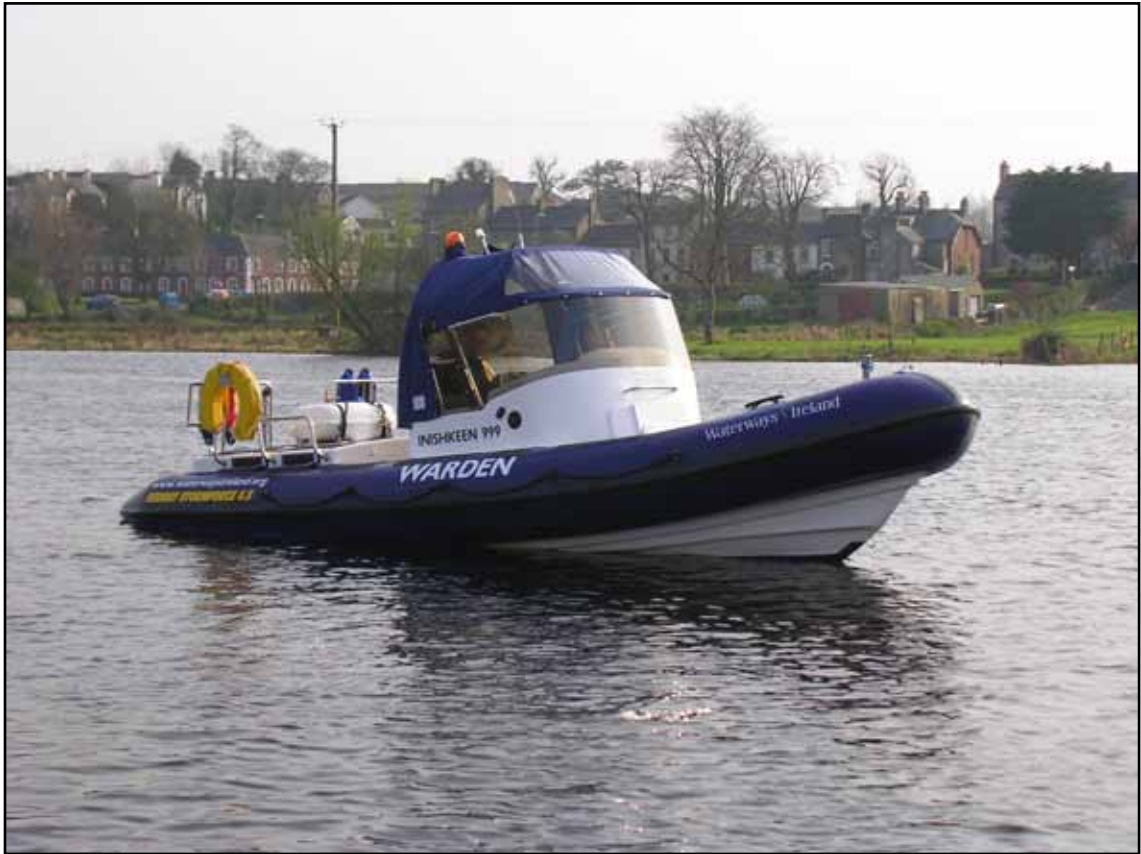
During the winter of 2007 / 2008, *Sooty* was modified to give greater protection from adverse weather and sea conditions. The modifications were copied from the design of another RIB, the Redway Boats Stormforce 6.5 (**Figure 8**) and included:

- A full breadth 'wrap around' console, moulded into the side tubes.
- A deeper visor following the lines of the modified console, with a bronze tint.
- A stainless steel frame over the console, complete with canvas awning and clear plastic inserts.
- The repositioning of an air bottle stowage from an athwartships line, to the fore and aft line.

Craft similar to *Sooty* post modifications
